# EVALUATION OF A COMPRESSION-LOADED-STITCHED-MULTI-BAY FUSELAGE PANEL WITH BARELY VISIBLE IMPACT DAMAGE\*

Donald J. Baker  
Vehicle Technology Directorate - ARL  
NASA Langley Research Center  
Hampton, Virginia 23681

Jian Li  
Structural Integrity Department  
The Boeing Company  
Mesa, Arizona 85215

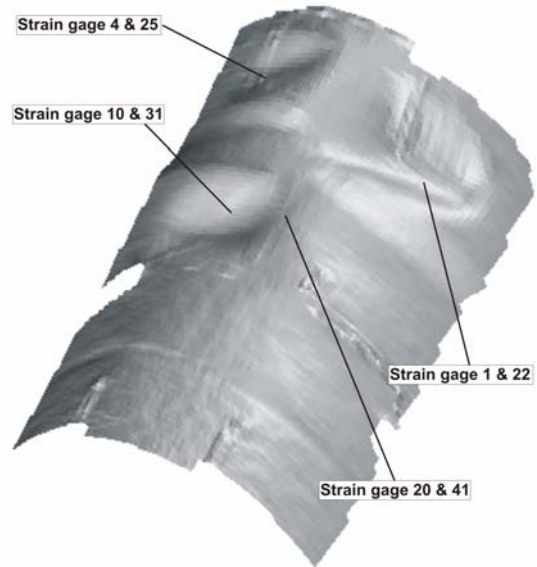
Figure 9a – Deformed shape of panel at  $N_y = 1.63P_{cr}$ .

The deformed shape of the panel at  $N_y = 1.63P_{cr}$  (last image before failure) is shown in Figure 9a along with the strain gage locations where the results are given in Figures 9b through 9f. Strain results from gages 1 & 22 in the first bay to buckle are shown in Figure 9b. This figure and subsequent figures will include strain gage results from before impact, after impact, and strain results extracted from the VIC-3D images taken during the test to failure after impact. The critical buckling load,  $P_{cr}$ , used to normalize the data is the actual buckling load determined in the test. The critical buckling load for the post-impact test is approximately 97% of the buckling load for the before impact test. Results shown in Figure 9b indicate bending in the panel starts at approximately  $N_y = 0.65P_{cr}$ . The results for the gages from before and after impact are identical from initial loading to failure. The strain results extracted from VIC-3D, shown by the curve with a diamond symbol in Figure 9b, also match the strain, determined by strain gages to the buckling load. From the buckling load to failure the VIC-3D strain data deviates from the gage data by increasing at a higher rate than the strain gage results as load increases to failure. One possible explanation for this deviation is that as the buckle grows deeper the surface that is being photographed is approaching the limits of the depth of field for the particular camera/lens setup.

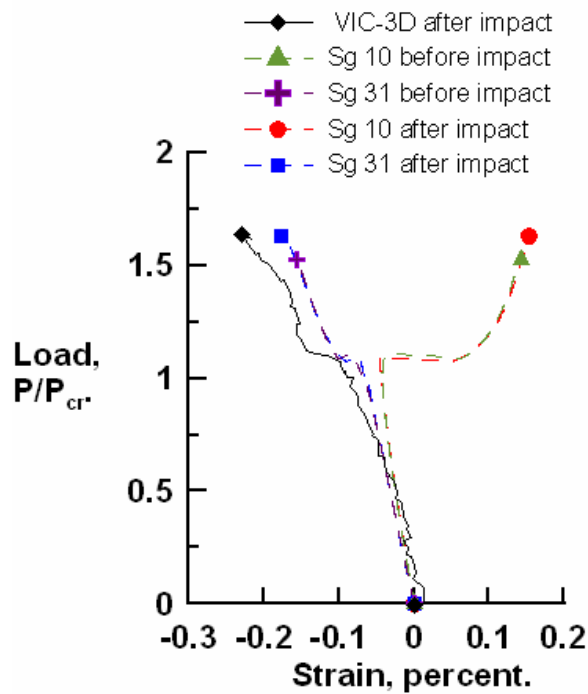
Figure 9d - Strain as a function load for strain gages 10 and 31.

Results at the point when the second bay buckles (middle L/H side) are shown in Figure 9d, for strain gages 10 and 31. The strain gage results from before impact test and after impact test match up to the failure point. The strain computed from the VIC-3D images compared well with the strain gage results up to the buckling point of the bay. The VIC-3D results indicated a step in the strain when the bay snapped into a single half wave of approximately twice the strain indicated from the strain gages and then maintained approximately the same slope as the strain gages.

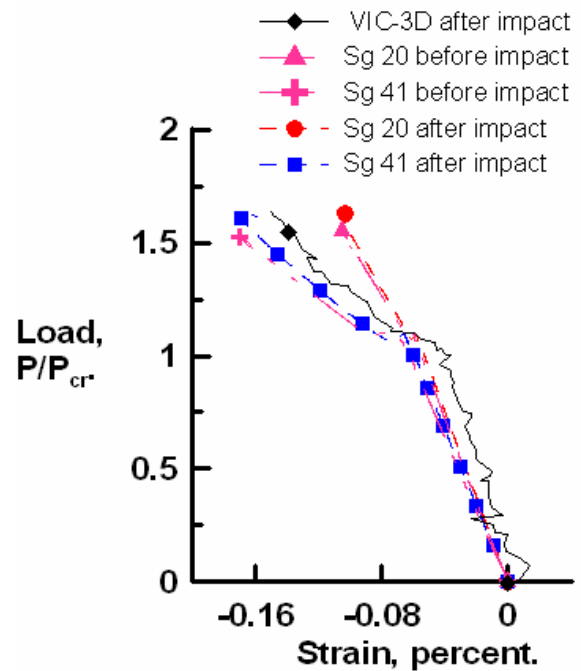
Figure 9e – Strain as a function of load for strain gages 20 and 41.

The result for strain gages 20 and 41, which are back-to-back gages located on the centerline stringer flange (gage 20) and OML (gage 41) at the panel center, are shown in Figure 9e. The strain gage (41) on the skin side indicates a step in the strain when the middle L\H bays buckles. The slope of the load-strain curve changes when the bay buckles and indicates an increasing strain on the OML side. Post-buckling stiffness of the skin is lower than the pre-buckling skin stiffness. The load strain curve extracted from the VIC-3D images is shown as a solid line with a diamond symbol and follows the same trend as strain gage on the OML side.

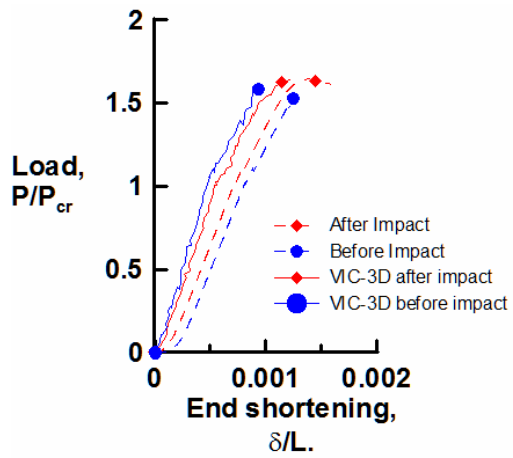
Figure 10 - Panel end shortening

The panel end shortening is shown in Figure 10. The dashed lines in Figure 10 are the results from LVDT data, while the solid line is for data extracted from the VIC-3D images. The end shortening per unit length for the LVDT data is determined by dividing the overall change in the distance between the platens by the panel unloaded length (28.4-inches). With the VIC-3D data the displacement and point location at two points is determined and the change in length is divided by the distance between the points.

A least squares fit has been calculated for each set of data from  $P/P_{cr} = 0.1$  to 0.9. There is a 2% difference between the slopes of the before impact and after impact curves as determined by LVDT's. As indicated in Figure 10, panel stiffness is higher as determined by the VIC-3D data than the stiffness determined from the LVDT data. The slope of the before impact VIC-3D curve is 135% of the slope of the curve for before impact with LVDT's. The slope of the VIC-3D curve for after impact is 87% of the slope for the before impact.

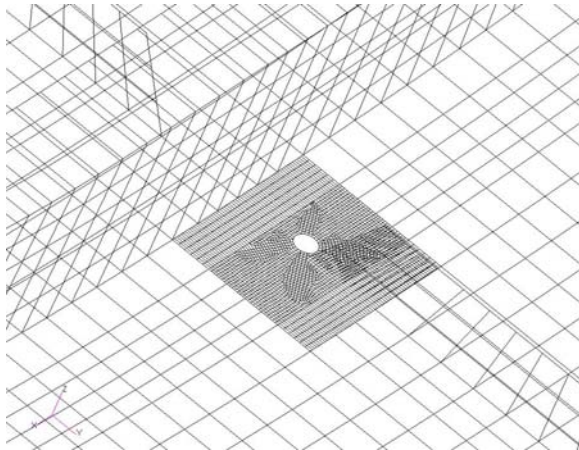
**Figure 12. Barely visible impact damage modeling for panel C-1.**

From the actual measurement and location of the impact damage shown in Figure 4, an accurate representation of the impact damage was created through local modeling that takes into account the damage size and location with respect to the center stringer centerline and distance from FS 154. A close-up of the finite element model of the impact site is shown in Figure 12. The nonlinear analysis used in reference 3 was modified to include the barely visible damage and was used to predict the panel response. Tie boundary condition was used to enforce displacement compatibility between the local model and the global model developed in Reference 3. The axial strain (y-direction) distribution at the OML ply predicted by the nonlinear analysis at  $P=1.63P_{cr}$  is shown in Figure 13. The results in Figure 13 demonstrate a global instability along FS 154 due to stringer web terminations. Also of interest is the fact that at the stringer termination location, the compression strain has a higher compression strain than anywhere else including the impact damage location. The predicted deformed shape of folding along FS 154 shown in Figure 13 compares well with the experimental observation shown in Figure 11.
